Re: **GREENWOOD SMELTER RUINS**

As requested, Metro Testing Laboratories Burnaby (Metro), a division of CCMET Inc., examined selected masonry, mortar and brick samples of the BC Copper Company Smelter ruins and heritage site at Greenwood, BC (Fig.1 and Fig.2). The site work took place on 19 and 20 April 2017, followed by laboratory testing.

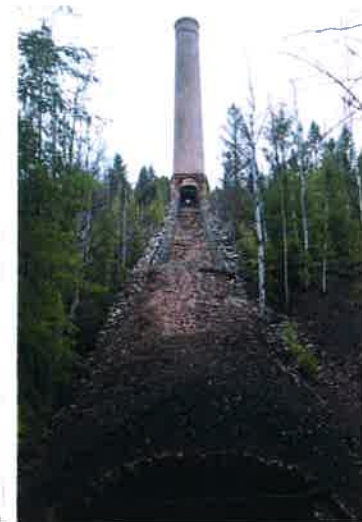
Figure 2 – General view of the smelter's flume and chimney

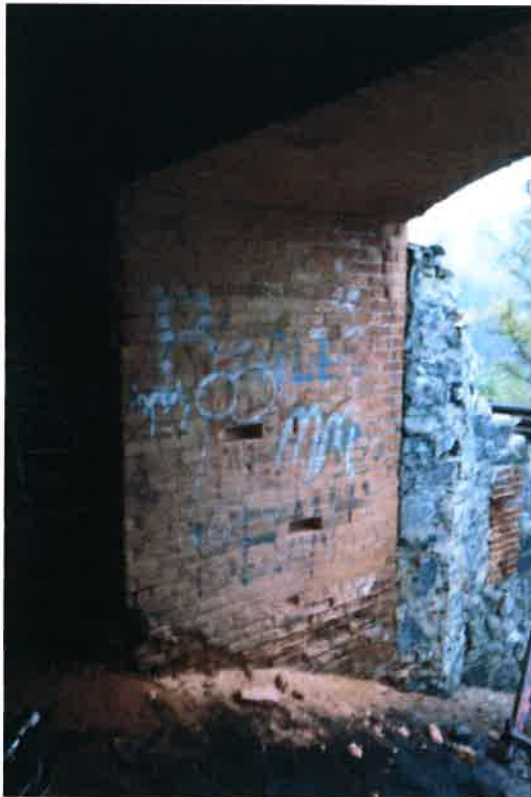
The clay bricks are approximately 20 cm x 10 cm x 6 cm, massive and of red colour. The bricks typically have a rough surface texture and are set in white lime mortar. The masonry is typically exposed. However, the inside of the chimney is coated with a glassy slag, very likely deposited by the smelting fumes (Figures 3 and 4). Of further note are the conditions of the bricks inside the chimney where accessible from the ground. Here the bricks had suffered spalling and delamination to approximately 3 cm beyond their present surface. In addition, masonry near the bottom had eroded by approximately one to two wythes.

Figure 3 (left) – Interior of the chimney

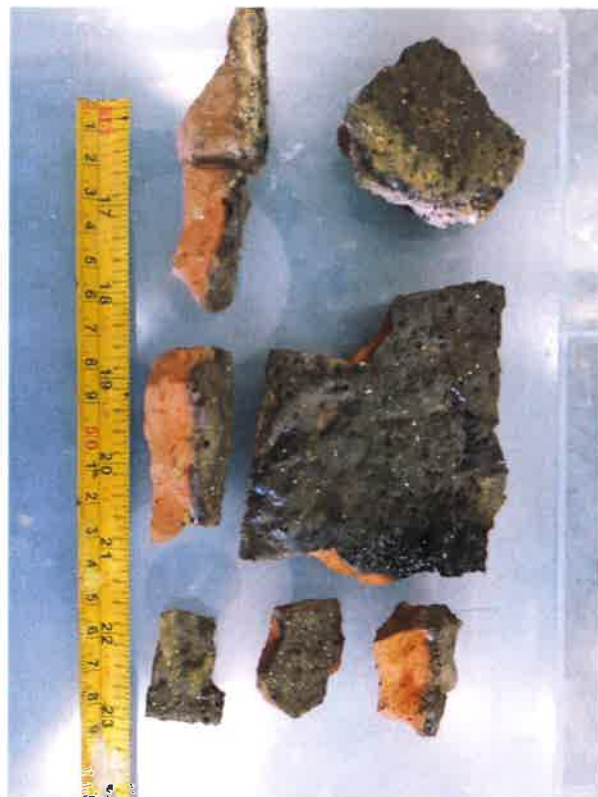
Figure 4 (right) – Detail of delaminated slag and bricks.

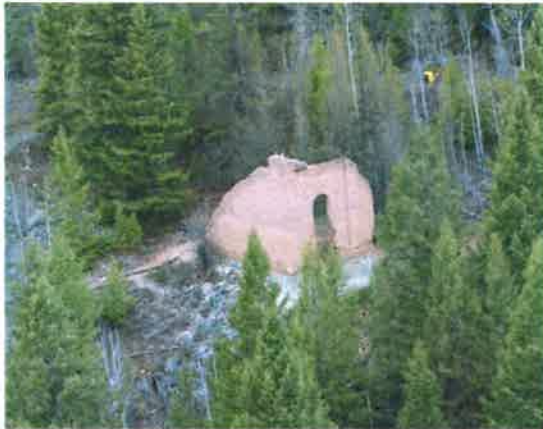
The corner building (Figures 5 and 6) had clay bricks with appearances and dimensions similar to the chimney bricks. The building’s foundation was comprised of granite blocks bonded with what apparently is the same type of mortar used for the clay bricks. Compared to the chimney, the mortar at the corner building appeared to be weaker, more friable, and in some cases loose and sandy, particularly in the foundations.

Figure 5 (left) – Aerial view of corner building.

While mortar and bricks are strong and still usable at the Chimney except where delaminated or weathered, the Corner Building's integrity is compromised. Although the bricks are fairly strong, the mortar is weak and deteriorated in many locations. Re-mortaring or deep re-pointing will be required to at least somewhat stabilise the masonry. The Structural Engineer may want to design additional measures to stabilise the wall.

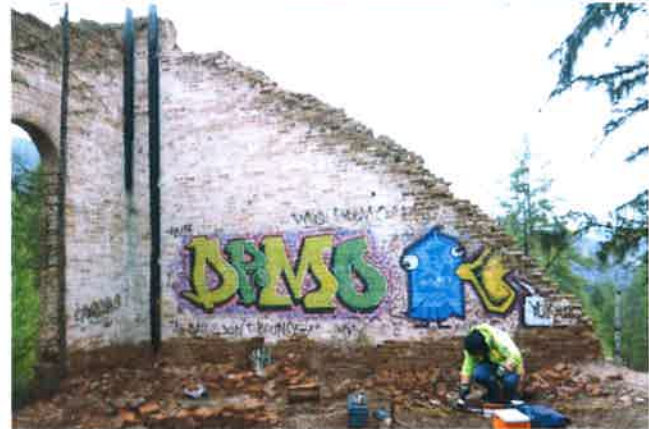
Figure 6 (right) – South view of the Corner Building wall.

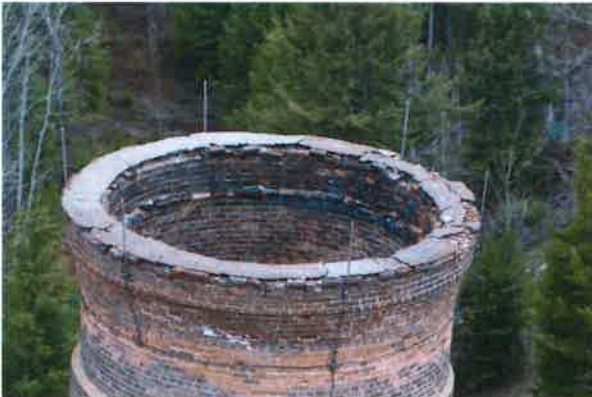
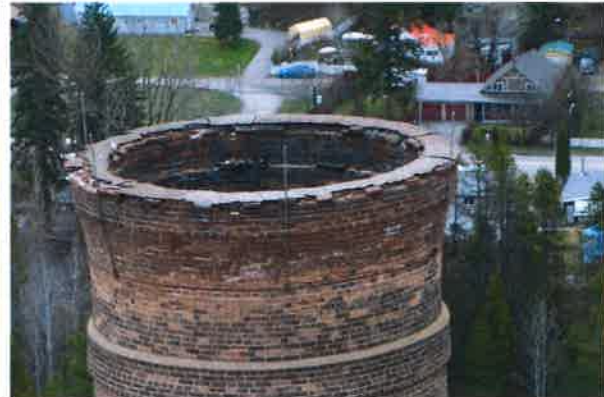
The top of the chimney was observed from a helicopter. Visual observation (Figures 7 and 8) revealed loose

bricks on the top and deteriorated mortar coating, presenting immediate falling hazards, particularly in the event of strong winds. Note that more photographs are on file.

Figures 7 (left) and 8 (right) – Top of the chimney. Note loose bricks and mortar in imminent danger of falling.

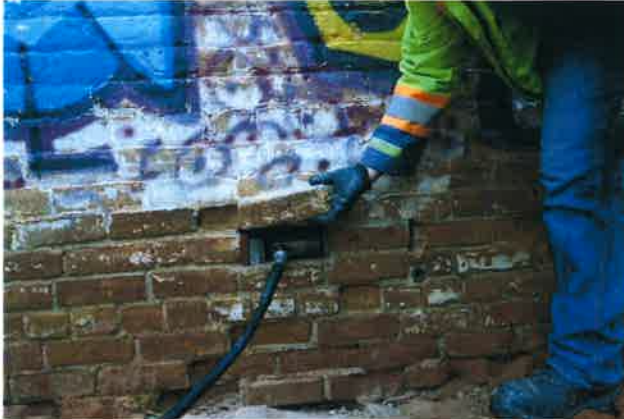
Figure 13 – Detail of testing equipment and brick #1 (Corner building)

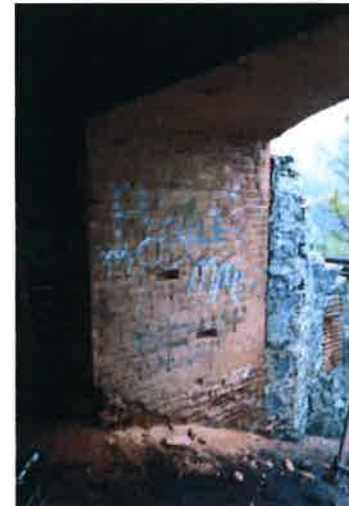
Figure 16 – Locations #3 & #4 (Chimney)

Clay brick masonry was tested for shear resistance on site. Metro was able to conduct shear tests to failure in two locations at the Corner Building. In the two test locations at the chimney, the shear resistance of the bricks exceeded the maximum capacity of Metro’s testing equipment.

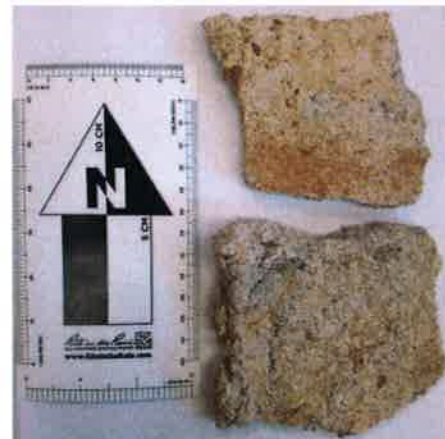
Using a pocking knife and conducting a cursory petrographic analysis of mortar sampled at the Corner Building (Figure 12), the compressive strength was estimated to be in the 2 MPa range.

The mortar is estimated to contain 26% lime, 62% fine sand

Figure 12 – Lime mortar from Corner Building.

>1mm (Mostly quartz particles and minor amount of darker grains (volcanic)), and 12% air voids.

Some of the pores were filled with lime, which suggests that the porosity was originally in the 15-18% range, but reduced over time due to the autogenic<sup>1</sup> ("self-healing") properties of lime mortars.
