Re: **GREENWOOD SMELTER RUINS**

As requested, Metro Testing Laboratories Burnaby (Metro), a division of CCMET Inc., examined selected masonry, mortar and brick samples of the BC Copper Company Smelter ruins and heritage site at Greenwood, BC (Fig.1 and Fig.2). The site work took place on 19 and 20 April 2017, followed by laboratory testing.

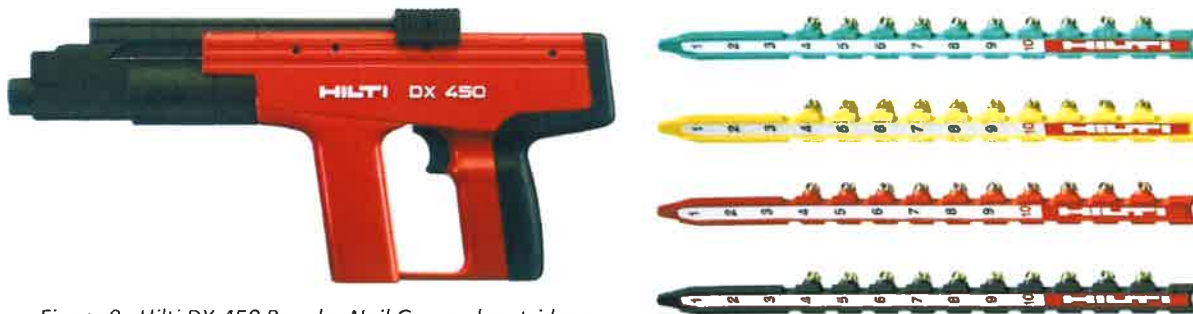
Figure 9– Hilti DX-450 Powder Nail Gun and cartridges.

Penetration tests were conducted to determine the compressive strength of the mortar. Metro unsuccessfully attempted first the 3 mm diameter needle hand penetration test. However, the mortar was stronger than testable with the penetrometer, so we switched to the Hilti Dx-450 powder actuated nail gun (Figure 9) using different cartridges as appropriate for the specific locations (White – lowest power, Green intermediate power).

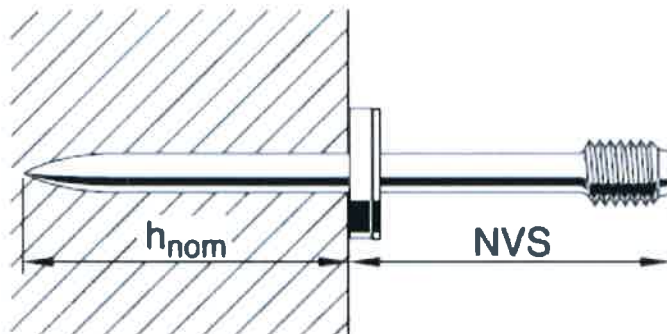
Figure 10 (left) Threaded studs used for penetration test.

This method is based on EN 14488-2 and Sika's Shotcrete Early Strength determination procedures. Compressive strengths between 3 and 20 MPa are determined by threaded studs (Figure 10), which are driven into the shotcrete surface. The relation between the depth of penetration ( $h_{nom}$ ) and the pull out resistance infers a compressive strength according to the calibration curve (*Appendix – Calibrations*). Ten readings per measurement are necessary. The measurement tool for this method is the Hilti DX 450 with green cartridges and a pull out device (Figure 11).

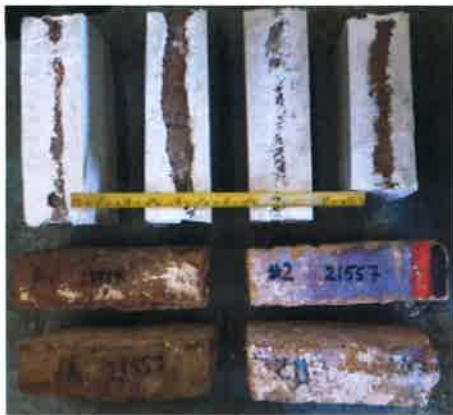
The bricks were capped (Figure 17) with Hydrostone capping compound to ensure proper contact of the bearing plates. After the capping compound had cured, we loaded the bricks individually in Metro's Forney UTM until failure (Figures 18, 19 and 20). Results are summarized in Table 1. Additional notes are included in *Appendix – Test Results*.

Figure 17 – Capped bricks (top) from the Chimney and bricks ready to cap (bottom) from the Corner Building.

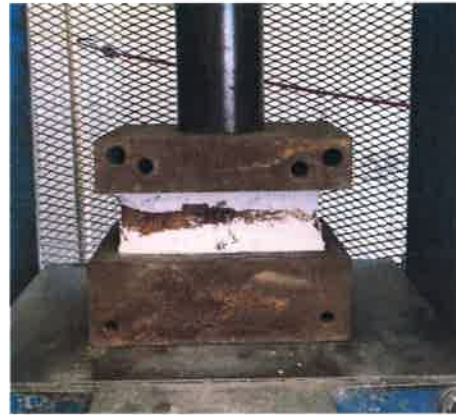
Figure 18 – Specimen #1 during compressive strength test.

The lowest compressive strength of the bricks is in the 17 MPa range. Any repair should be performed with a Type N or S mortar as per ASTM C270 and CSA S304.
